# REFURBISHMENT OF VERTICAL PUMP SUCTION BELLS USING BELZONA FOR PROTECTION AGAINST SALTWATER EXPOSURE

ID: 10011

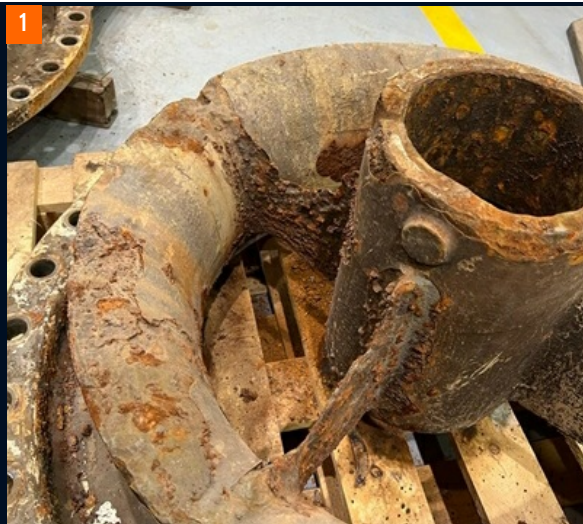
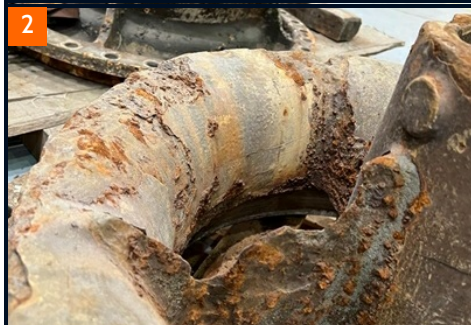
The supports and flow straighteners on the suction bell were heavily corroded and eroded due to prolonged exposure in seawater service.

The suction bell was fully corroded and eroded especially at the support areas.

1. The suction bells exhibit severe corrosion and erosion as a result of prolonged exposure to saltwater.
2. Suction bells deteriorated by severe saltwater corrosion and erosion
3. Suction bells repaired with Belzona 1111 (Super Metal) and overcoated with Belzona 5821
4. Belzona 5821 overcoat applied to protect equipment operating in immersed conditions
