# ROOF FLASHING COVER UPGRADED WITH BELZONA

ID: 10040

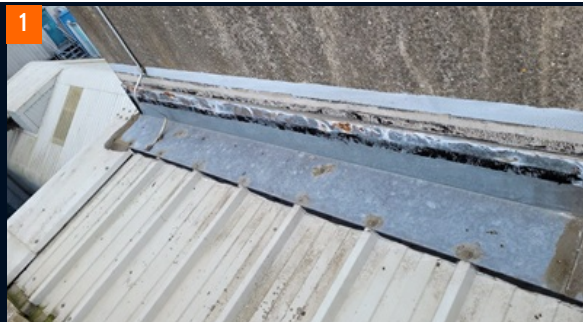
A roof flashing had become detached from the concrete side wall, leading to water ingress issues between the roof and the side concrete structure.

1. Original problem area showing leaking flashing baffle.
2. Flashing not sealing between concrete face and over existing roof.
3. Completed repair using the Belzona 3131 system.
4. Face on view of the complete Belzona 3131 system repair.
