# CONCRETE REPAIR TO ROLLER SHUTTER ENTRANCE REPAIR

ID: 10079

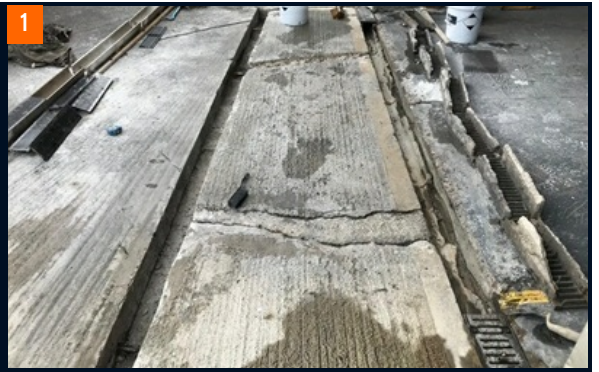
Constant heavy traffic had caused wear and damage to the apron leading toward the entrance of a large roller shutter door. The FLT were vibrating and unseating their loads, making the area dangerous for Forklift Traffic and anyone in the immediate area

1. Showing wear and heavy damage to the area
2. Further view of damage
3. Completed repair using Belzona 4131
4. All complete and ready for production

Break out all loose and friable

Vacuum the whole area

Apply Belzona 4911 as per Belzona 4131 IFU

Mix and apply Belzona 4131 as per Belzona 4131 IFU
