# BELZONA REPAIR TO INTERNAL ROOF DRAIN STILL OK 24 YEARS LATER

ID: 1008

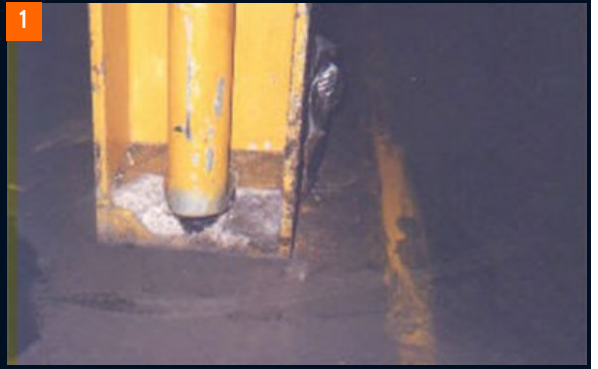
Hit by a fork lift truck, the pipe broke off at the floor level and leaked water everytime it rained.

1. Broken pipe, summer 1984
2. Repair completed
3. Revisited February 2008 and still performing

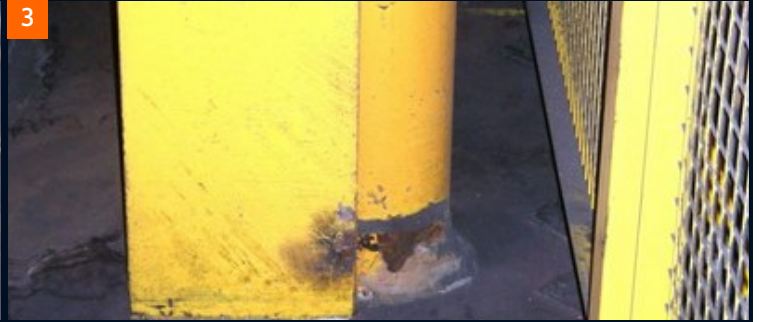
To change the broken pipe would involve a pipefitting/labor crew at least a week to excavate down below the floor three feet. Belzona application took just 20 minutes to complete. 8 man crew, 40 hours labor at \$50.00/hr = \$16,000 saved. Revisited February 2008, still performing.
