# BELZONA ELASTOMERS FOR FENDER REPAIR IN NEW ZEALAND

ID: 10083

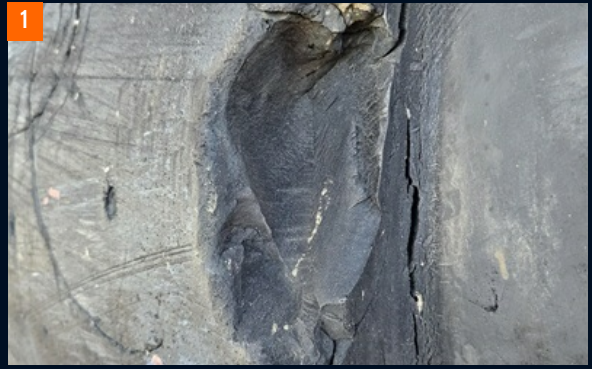
Deep gouges and loss of the original substrate was causing mooring ropes to catch and cause further damage to the fender of a tugboat. Replacement would involve a large amount of time and considerable cost

1. Large tears and gouges reduced the efficacy of the Fender and caused ropes to become caught
2. Damaged areas were cut back to remove any loose material, and then prepared with a rotary burr before conditioning with GP Conditioner
3. Dams were glued in place to retain the Belzona product during curing
4. Belzona 2131 (D&A Fluid Elastomer) fluid was mixed with shredded rubber aggregate and applied into the repair areas
