# 20" CRUDE OIL LINE REPAIR USING BELZONA NON- COMPLIANT SUPERWRAP II

ID: 10094

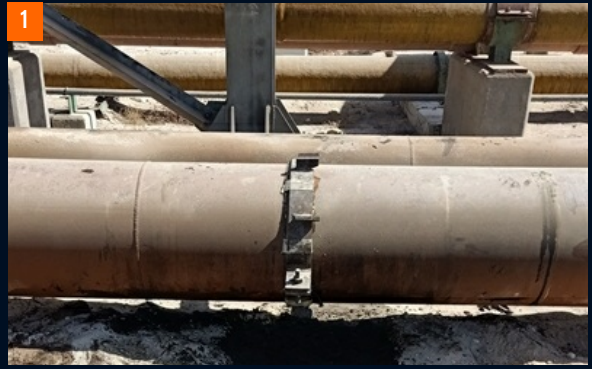
A 20-inch crude oil pipeline operating at ambient temperature was found to have two 10 mm through-wall defects at the 6 o'clock position, one of which was actively leaking. The line was shut down due to safety concerns; however, heavy oil sludge within the pipeline continued to melt and drip under high ambient temperatures, making leakage control difficult.

1. The 20" pipe was clamped by the customer due to severe leakage.
2. Second Location
3. After successful application of Belzona SuperWrap II (3 wraps)
4. No leaks were observed in the Belzona SuperWrap II repair after four months of service.

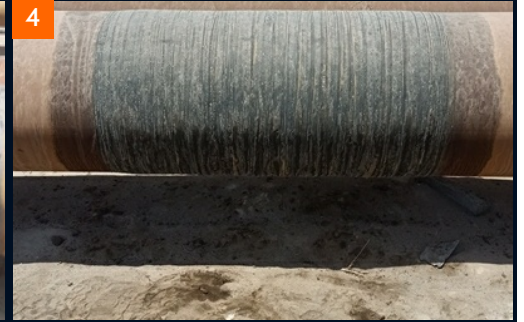
The Belzona system provided a safe alternative to welding and enabled a durable repair despite the challenging oil-contaminated conditions. The pipeline was returned to service in less than five days, allowing the customer to avoid extended downtime and production loss. After four months, the repair was inspected and found to be completely intact with no leaks, further enhancing the customer's trust and confidence in Belzona solutions.
