# TRANSFORMER FINS LEAK REPAIR USING BELZONA

ID: 10167

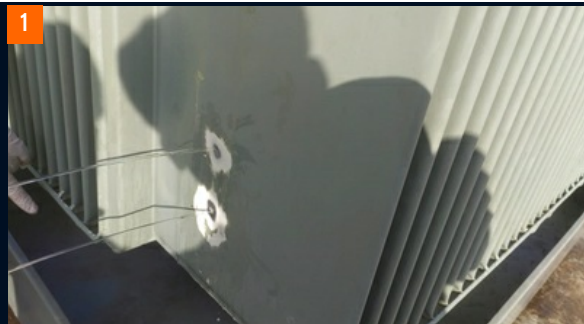
The customer experienced a leak in one of their oil transformer fins caused by external corrosion. Replacing the fins was not feasible due to the long lead time for new components.

1. Leakage in the Transformer Fins
2. Surface Preparation of the Leakage Area
3. Application of Belzona 1212 with Belzona 9341 Reinforcement Tape
4. Other Areas Repaired with Belzona 1212 and Belzona 9341
