# BELZONA REPAIR OF LEAKAGE ON A DIESEL FUEL STORAGE TANK

ID: 10214

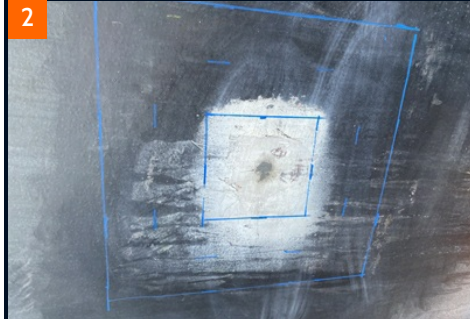
The customer identified a small leak originating from behind an existing doubler plate that had been installed decades ago, with no records available. The area in question was approximately 8 m above ground level. When the original plate was removed, a small circular dent was observed with a hairline crack of approximately 1 mm above it. Diesel from the tank was weeping through this crack and beneath the plate.

1. Original defect after cleaning and degreasing.
2. The defect area was filled with Belzona 9611 (ES-Metal) as a temporary measure to allow hot-work surface preparation of the surrounding repair area.
3. Surface preparation of the area including cutting in area for the paint to overlap.
4. Doubler plate installed with chamfered edges, ready for painting.
