# PIPELINE LEAKAGE ARREST AND REINFORCEMENT USING BELZONA COMPOSITE SYSTEMS

ID: 10247

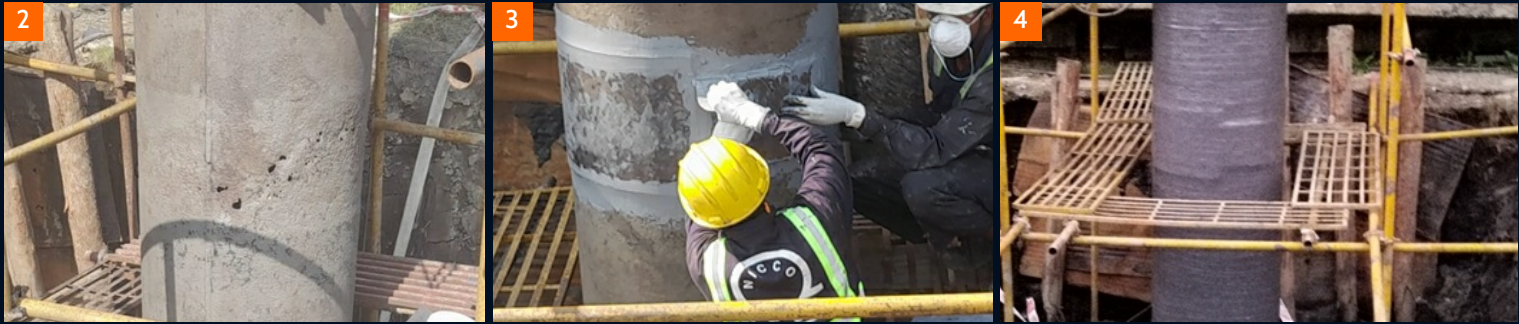
1. From ground level to a height of approximately 1.5 m, the riser pipe had deteriorated due to the presence of algae and bacteria below ground level. The section in question had previously been wrapped with bitumen in an attempt to provide protection.
2. Surface was prepared with copper slag grit blasting.
3. Belzona 1161 (Super UW-Metal) applied to rebuild damaged portion followed by plate bonding
4. Finally, the affected areas were reinforced with Belzona 5841 and Belzona 9371 composite repair system

1. The surface was cleaned, then grit blasted.
2. Then, after careful observation and dimensional inspection, the holed areas were plate-bonded with MS plate and Belzona 1161 (Super UW-Metal).
3. The other dimensionally compromised areas were rebuilt with Belzona 1161 (Super UW-Metal).
4. Then, the composite repair system, comprising Belzona 5841 and Belzona 9371 Glass Fibre Reinforcement Sheet, was then applied to help restore the pipe's surface profile, improve external protection, and reinforce the affected area against further environmental and bacterial deterioration.
