# BELZONA FLANGE REPAIR ON CIRCULATING DISCHARGE WATER PIPE

ID: 10281

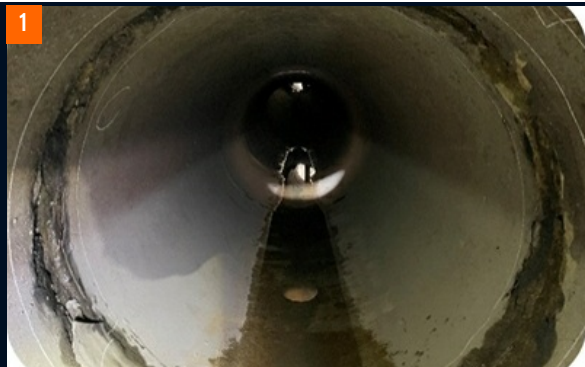
The internal flange coating of the circulating water pipe discharge circulation pipe was found to be damaged and delaminated, leading to the development of water channels beneath the coating layer. This deterioration compromised the integrity and protective performance of the coating system, exposing the substrate to potential corrosion and further degradation.

1. Damage on the flange of circulating water pipe discharge circulation pipe
2. Surface preparation by a power tool
3. Belzona 1311 (Ceramic R-Metal) filled the flange
4. Belzona 5831 (ST-Barrier) coated flange surface subject to wet conditions
