# BELZONA RESTORES DAMAGED BUCKET ELEVATOR CONVEYOR BELT AT A CEMENT PLANT

ID: 10328

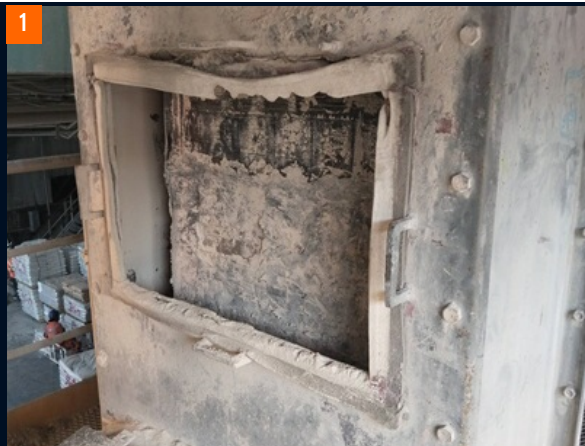
The bucket elevator conveyor belt suffered severe rubber damage due to continuous service, compromising its structural integrity and increasing the risk of sudden failure and unplanned production downtime. The deteriorated section required immediate restoration to maintain safe and reliable operation, eliminate the need for immediate belt replacement, and allow the equipment to be returned to service within the scheduled maintenance period.

1. Rear side of the bucket elevator belt showing severe rubber damage prior to repair.
2. Close-up of the damaged bucket elevator belt showing severe rubber deterioration and material loss prior to repair.
3. Front view of the bucket elevator belt showing the corresponding repair location.
4. Completed Belzona repair restoring the damaged bucket elevator belt for return to service.

Loose and damaged rubber was removed before the repair area was thoroughly cleaned and degreased. Belzona 2911 (Elastomer QD Conditioner) was applied to condition the rubber substrate and promote optimum adhesion. Belzona 2221 (MP Fluid Elastomer) was then applied together with Belzona 9341 Reinforcement Sheet to restore the structural integrity of the damaged belt. The repair profile was rebuilt using Belzona 2211 (MP Hi-Build Elastomer), followed by the application of Belzona 2131 (D & A Fluid Elastomer) as the final protective topcoat, completing the repair and preparing the belt for return to service.
