# I.D. FAN SHAFT REPAIRED IN SITU WITH BELZONA

ID: 1034

Shaft of induced draft fan.

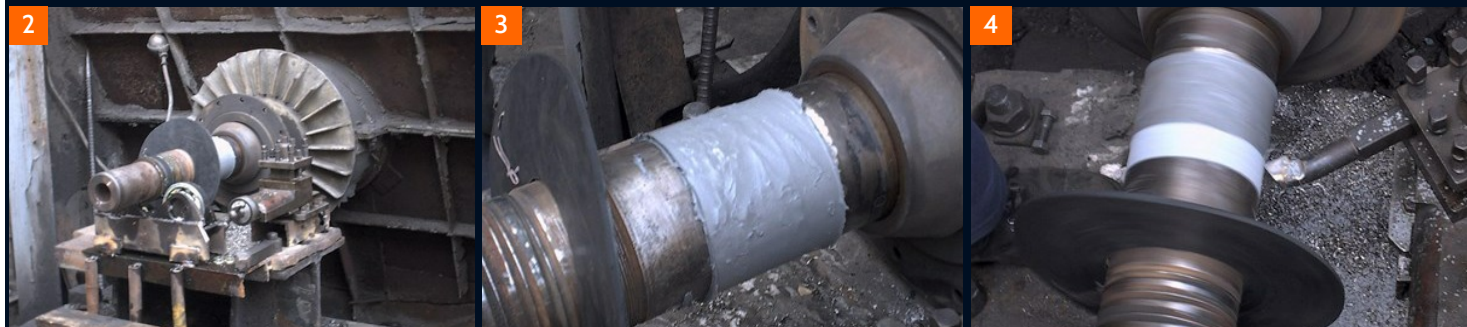
Shaft damaged at bearing location by seized bearing.

1. Damaged area of the shaft undercut
2. All machining and application work carried out on site by using fan rotation and small hand lathe
3. Belzona 1111 applied
4. Machining to the final diameter

Application was carried out in accordance with Belzona Know-How System Leaflet MPT-1. The journal was prepared and machined in situ using the draft of the gases to rotate the shaft. Simple small lathe was mounted to machine the area to desired diameter.

Belzona used to rebuild the original dimensions of the shaft without dismantling the fan. Belzona returned the equipment in service with minimal production down time. This procedure has become standard for emergency shaft repairs in the plant.
