# BELZONA REPAIR OF DIESEL ENGINE CASING

ID: 1054

Yanmar diesel engine of electrical generator from vessel

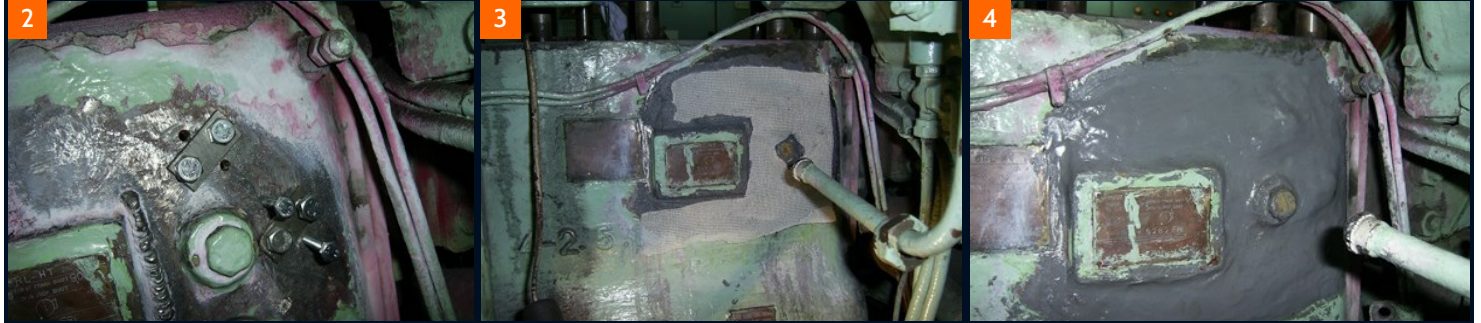
Damaged casing of the engine with leakage of cooling water from the water jacket.

The conventional repair by welding was done previously without success. The welds cracked soon due to the induced stresses and brittle condition of the engine casing. All conventional repair companies refused any repair. After application and test runnings of the engine the customer was fully satisfied with the results. Belzona solution was time and cost effective and saved the customer replacement costs.

1. View of the cracked casing
2. Crack terminated and metal reinforcement straps fixed
3. Application of Belzona 1111 with additional Belzona 9341 (Reinforcement Tape) in progress
4. View of the completed application

Application was carried out in accordance with Belzona Know-How Leaflet ENC-1. The internal surface of the casing was additionally protected with a coat of Belzona® 1392.
