# BELZONA GIVES LIFE TO PUMP

ID: 1096

Large pump 16 NDN working in drainage system.

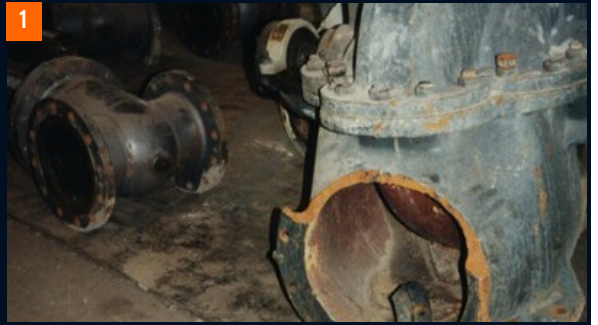
Due to inaccurate assembling of suction pipe and pressure pipe both suction and pressure flanges were torn off the pump body.

1. Pump lost its flanges
2. Flanges are in place again with Belzona 1111
3. The pump is restored
