# BELZONA REPAIRS CYCLONE INLET

ID: 1171

Pulp & Paper

Paper Mill, Michigan U.S.A.

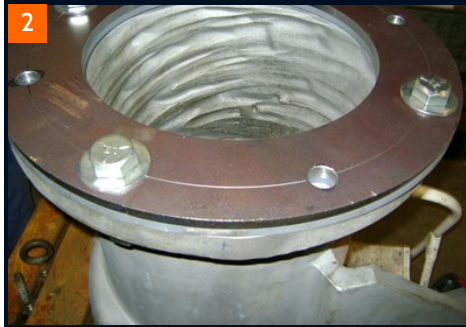
The inlet to the pulp cyclone showed severe erosion corrosion after only 8 months of service. It had already been patched once and had holed through again.

1. The fitting in the repair area
2. Flange form installed. Internal damage evident
3. Belzona 1321 being applied over the Belzona 1812
4. Completed repair
