# BELZONA SEALS FLOATING TANK ROOF

ID: 1173

## PROBLEM

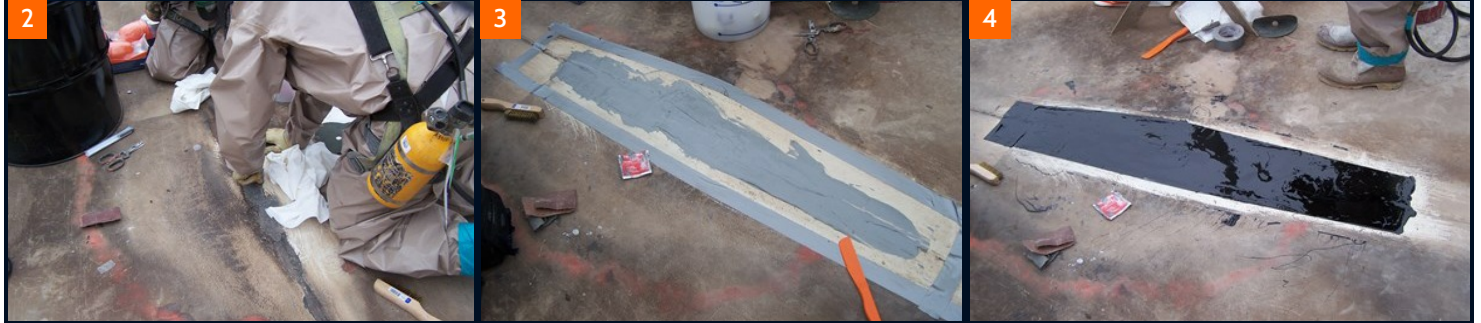
There was substantial head pressure in the tank resulting in loss of product containment through the corroded seam. This was not only an operations concern, but an environmental and safety issue as well.

Overlapped welded plate on floating tank roof was trapping water allowing corrosion.

1. Surface preparation of the seam
2. Belzona 1291 used to stop active leak
3. Area taped off and additional leak protection with Belzona 1221
4. Final coating protection with Belzona 2111

The active leak was stopped with Belzona® 1291. Repair area leveled with Belzona® 1221. Over-coated taped off area with Belzona® 2111 to provide flexible seal.
