# BELZONA REFURBISHES LOADER

ID: 1199

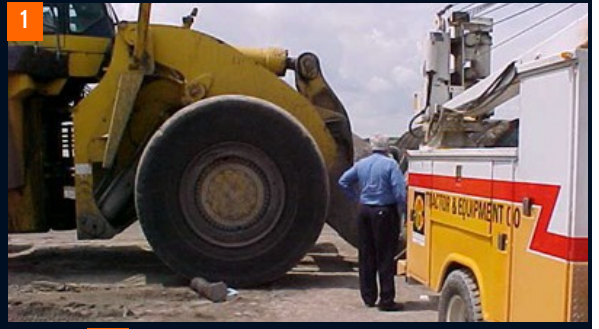
1. Overall view of the loader
2. Worn pin fit
3. Aligning the new bush
4. Final repair after new bushing is inserted

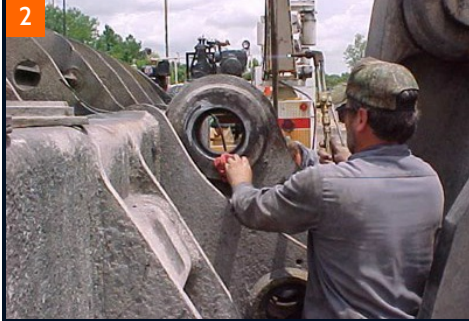
Sloppy pin fit allowed too much movement in the bucket arm. The bushing wore away allowing metal damage and lifting problems.

Loader lost a grease fitting and lack of regular lubrication resulted.
