# BELZONA BELT REPAIR KEEPS MINE PRODUCING

ID: 1229

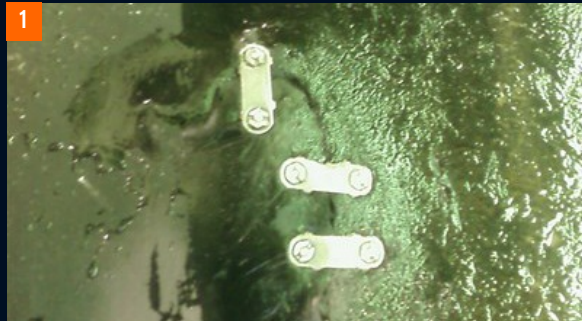
A large rock found its way between the drive roller & the belt, resulting in extensive damage to belt. Minimizing downtime was crucial!

Attempts to prevent belt from tearing further Belt cleaned and undercut Former with weights in place to form repair smooth and flush with belt surface Repair completed
