# BELZONA SOLVES FLAP VALVE DAMAGE

ID: 1231

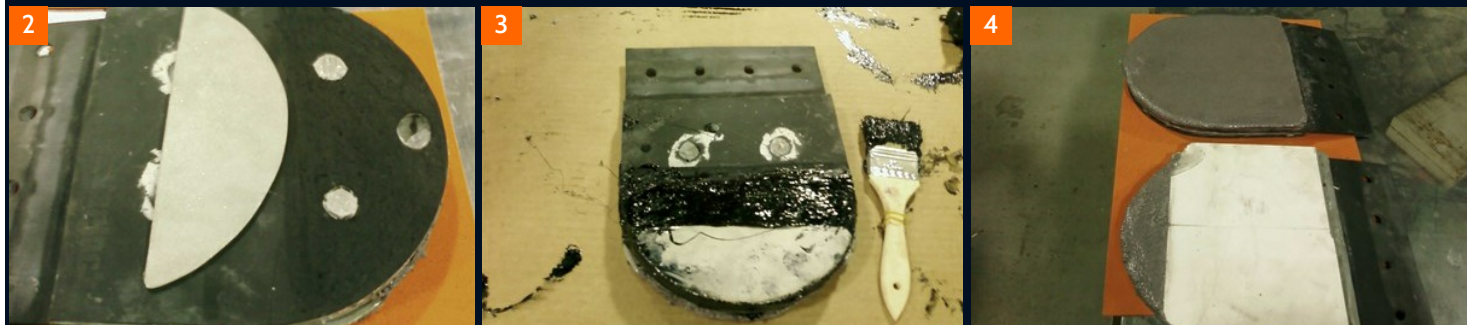
The valves suffered damage on the back of the valve plate due to impact with the valve "stop". This impact would cause breakage/failure of ceramic tiles on the front of the valve, allowing gypsum/perlite mix to cause abrasion damage and prevent valve from sealing upon closure leading to repeated outages of the system.

1. Valve plate showing impact damage on back from striking the valve stop
2. Striker plate and valve plate prepared for application
3. Striker plated bonded to back of valve plate with Belzona 2111
4. Ceramic tile repaired with Belzona 1812 on one valve, tile replaced with Belzona 1812 on second valve

Application was carried out in accordance with Belzona Know Show System Leaflet SHM-7. Belzona® 2111 was used to bond a stainless steel striker plate to the back of the valve plate to absorb and distribute the sharp point impact from the valve stop. Belzona® 1812 was used to repair valve with broken tile and ultimately replace tile altogether for abrasion resistance on front of valve.
