# CLASSIC BELZONA SHAFT REPAIR AT CEMENT PLANT

ID: 1241

Forced draft fan shaft for the kilns.

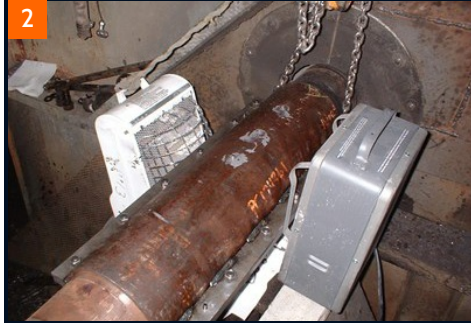
Kilns were to be shut down in approximately 4-6 weeks but failed split bearing caused scoring of shaft requiring urgent repair.

1. Shaft prepared
2. Split sleeve former
3. Rebuilt shaft being measured
4. Back in service

Application was completed in accordance with Belzona Know-How System Leaflet MPT-2.
