# BELZONA REPAIR TO DIAPHRAGMS IN STEAM TURBINE

ID: 126

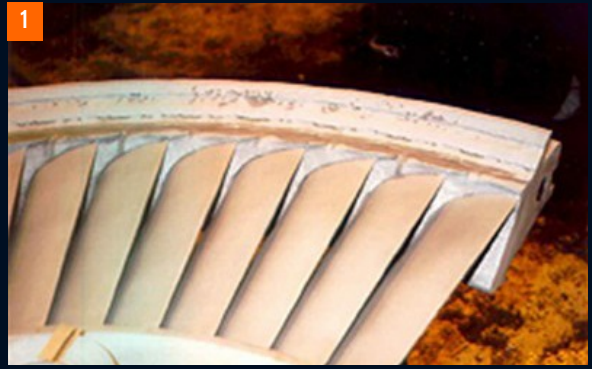
Severe erosion/ corrosion of the turbine diaphragms in the the latter stages of the low pressure side of the steam turbine. This had been caused by many years exposure to saturated steam and had resulted in a decrease in efficiency in the turbine.

1. Erosion damage on the diaphragm
2. Application of Belzona 1311 to restore profiles
3. Application of Belzona 1391 underway

Modified versions of Belzona Know-How Leaflets CEP-5 and CEP-3. Belzona® 1311 was used to rebuild the damaged areas. Sites rebuilt were then treated with two coats of Belzona® 1391.
