# CAVITATION DAMAGED IMPELLER REPAIRED WITH BELZONA

ID: 1260

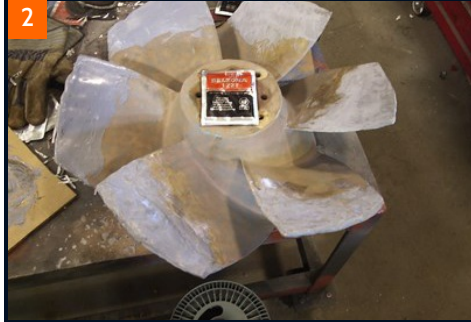
Impeller was damaged by cavitation leading to vibration in the pump. NSF approved products required.

1. Impeller showing Cavitation Damage
2. Impeller repaired with Belzona 1221
3. Impeller coated with Belzona 1341N
4. Impeller installed into pump and ready for service
