# BELZONA REBUILDS STAINLESS STEEL PUMP

ID: 1277

Double end suction centrifugal pump in pulp production

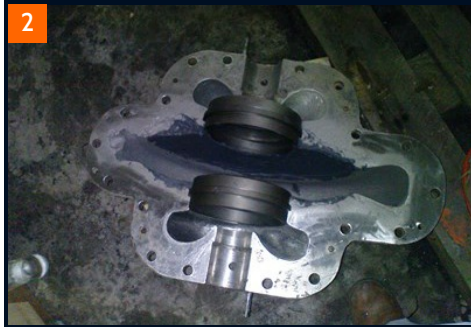
Loss of internal profiles of the pump casing as a result of corrosion and erosion processes leading to reduced pump efficiency

1. Damage to the pump casing after blasting
2. Rebuilding damage inside the casing
3. Flat metal plate used as former to rebuild flange faces
4. Pump rebuild completed

Application was carried out in accordance with Belzona Know-How system Leaflets CEP-1 and CEP-5. After blasting with Aluminium Oxide grit the internal damage was restored with Belzona® 1311. Flange faces & sealing ring seats were rebuilt by forming technique with Belzona® 1111.
