# BELZONA REFURBISH BLAST FURNACE "BELL ROD" IN-SITU

ID: 130

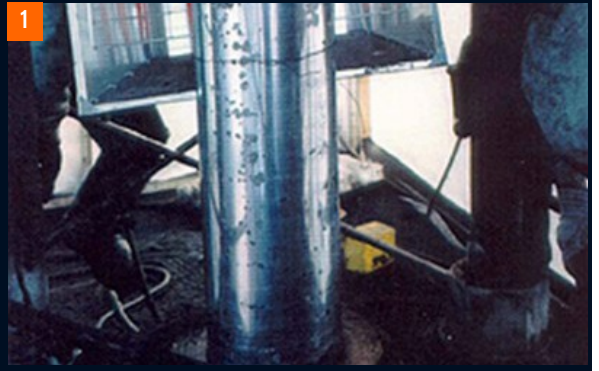
Chrome plating on the rod had been damaged in places which had allowed corrosion to take place. The size and location of the part made preparation difficult and reduced the opportunity for dimensional finishing of the job after application.

1. View of the damaged bell rod
2. Belzona 1321 being injected into the former
3. The completed job with admiring crowd
