# BELZONA REBUILDS FLANGE FACE ON FILTER

ID: 1346

Hydroelectric Power Plant, Russia

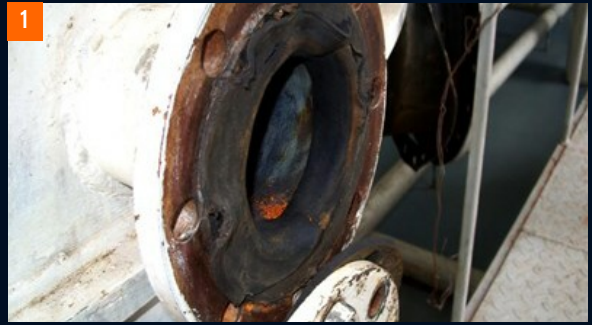
Rubber had been damaged due to long years in service and was badly deteriorated. Sealing of the flange lost. Rubber in seal area had lost adhesion to the substrate.

1. Deteriorated flange face before the application
2. Surface preparation to flange face
3. Completed application
