# PUMP BELL CASING REPAIRED AND PROTECTED WITH A LONG TERM BELZONA SOLUTION

ID: 1369

Sea water cooling system pump for a 60 MW turbine.

National Electricity Provider, Malta

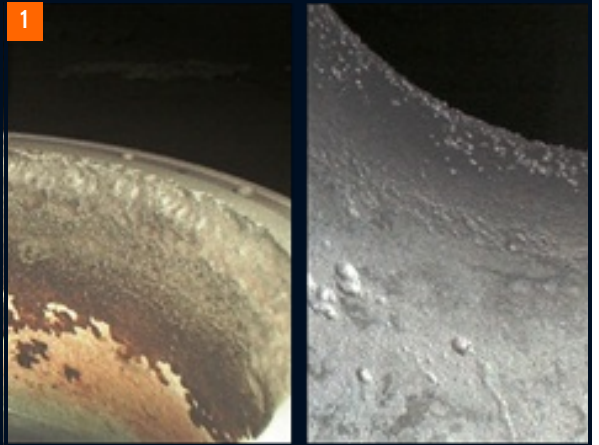
The original bell lining was failing on an annual basis, leading to pitting corrosion and regular replacement. The Belzona repair vastly improved reliability and performance. The pump casing, liner and diffuser were also repaired and coated, internally and externally. Yearly touch up is required of the sacrificial coating in the swept area due to cavitation damage. original Belzona protected bellmouth still in service after nine years.

1. Original system after 1 year in service
2. The finished Belzona application
3. Cavitation damage in the swept area
4. Ready to go back into service after touch up
