# BELZONA KEEPS HOSPITAL LAUNDRY BILLS DOWN

ID: 140

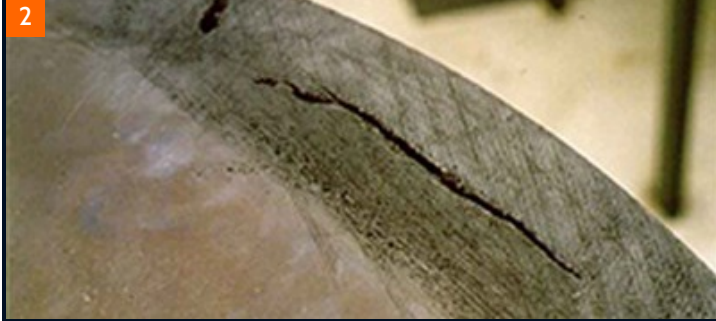
Wear and tear in service causes splits, in addition to mechanical damage caused by sharp objects left in clothing (a common occurrence).

1. The laundry press in operation
2. Typical split prepared and ready to have Belzona applied
3. Completing the Belzona 2211 application

Application was carried out in accordance with Belzona System leaflet VPF-5.

Belzona 2211 (MP Hi-Build Elastomer)
