# BELZONA SEALS DIESEL LEAK IN 60 MINUTES

ID: 1401

Diesel storage tank located at a terminal of a major oil company

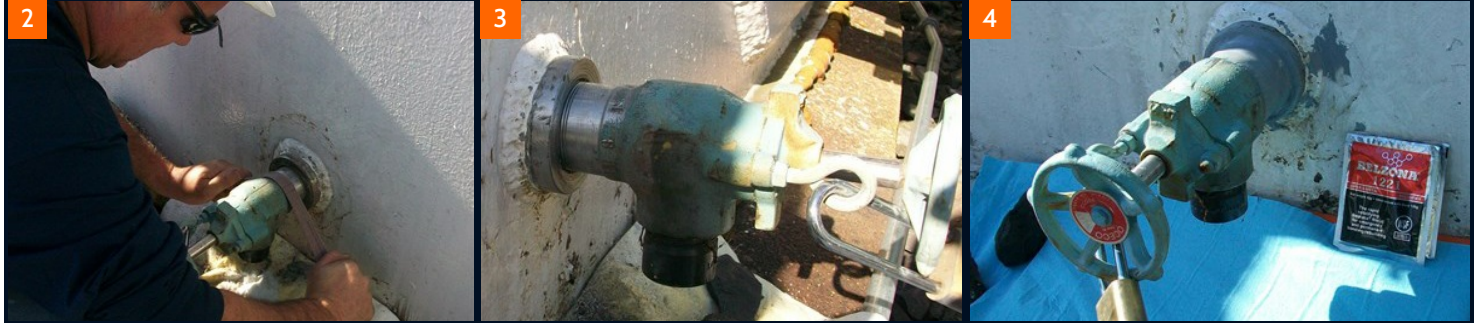
A valve located at the base of the tank was leaking. Terminal personal had attempted to seal the leak using an off the shelf water activated fiberglass wrap. They were unsuccessful. And the valve continued to leak.

1. Failed fiberglass wrap
2. Roughening the surface
3. Surface prepared and degreased
4. Application completed

Application was carried out in accordance with Belzosa Know-How System Leaflet VPF-11a. the failed fiberglass wrap was removed, the surface was prepared before wrapping the live leak with Belzona® 1221 and Belzona® 9341 (Reinforcement Tape).

Welding was not an option because the valve was located too close to the base weld of the tank. The entire Belzona repair was completed in less than an hour.
