# PROPELLER CAVITATION DAMAGE REPAIRED WITH BELZONA

ID: 1424

Bronze propeller of bulk carrier.

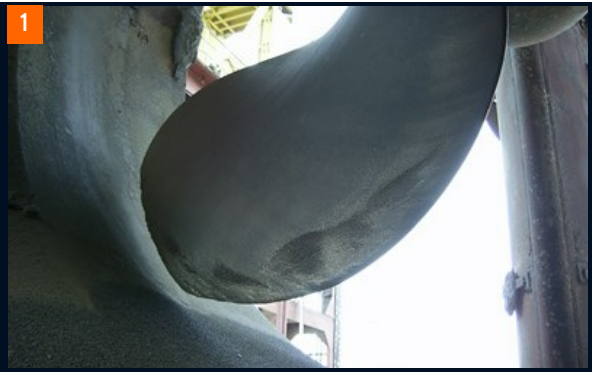
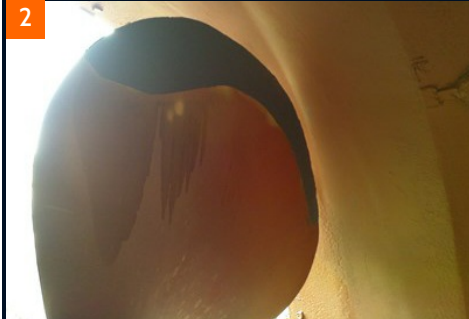
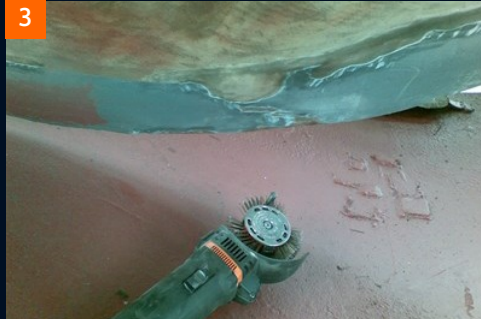
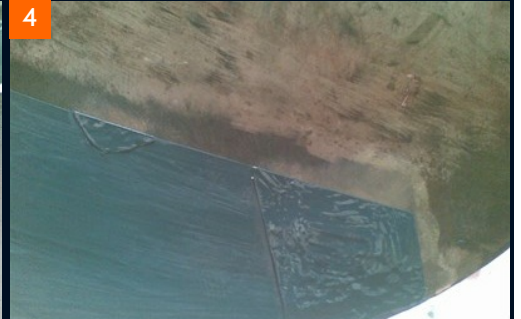
The cavitation damage close to the edges of the bronze propeller caused lower hydrodynamic efficiency and propulsion capabilities of the vessel.

1. The general view of cavitation damages after grit blasting
2. After rebuild with Belzona 1311 two coats of Belzona 1321 were applied
3. Inspection one year after the repair found some small mostly mechanical damage that were prepared by Bristle blasting
4. The damaged areas were corrected with Belzona 1321

The rebuild of cavitation damages by conventional welding and remachining were considered as too time consuming and required special skills to restore significant metal losses. The Belzona repair, in spite of being sacrificial, was chosen as more cost effective and time saving. After 1 year minor damage, mainly mechanical was found and locally repaired with further Belzona using an MBX Bristle Blaster for surface preparation.
