# BELZONA KEEPS OS&D HOSE IN SERVICE

ID: 1426

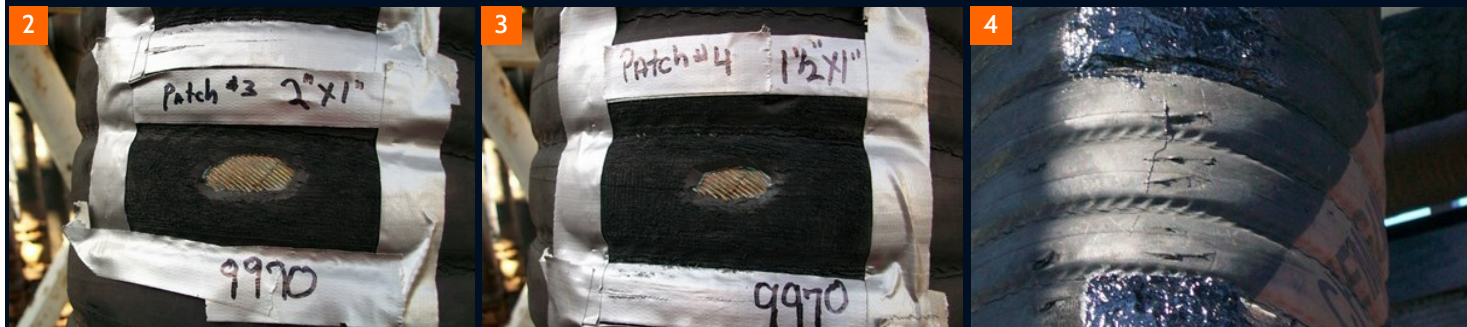
When inspected by the United States Coast Guard, even superficial scuffs and tears in the outer cover can result in hoses being tagged "out of service". Inspection showed that the reinforcement fabric had not been damaged.

Scuffs and tears to the cover of 8" OS&D (Oil Suction & Discharge) hoses.

1. Hose #9970 with 3 scuffed up areas exposing reinforcement fabric
2. Patch #3 area taped off and abraded
3. Patch #4 area taped off with Conditioner applied
4. Completed and ready for inspection

Application was carried out in accordance with Belzona Know-How System Leaflet SOS-12.

A typical 8" OS&D hose can cost \$3500 depending on length. Superficial damage, meaning damage to cover only, is common when dragged over docks and railings. The Coast Guard, however, can require these hoses be retired from service. If there is no damage to the reinforcement fabrics, a Belzona® 2111 patch system, when fully documented with before and after pictures, has been accepted by the USCG. These specific patches cost approx \$1200 in material and labor. 5 patches were installed on three hoses saving the customer approx \$11,000 in replacement costs
