# COOLING TOWER FAN BLADES REPAIRED WITH BELZONA PRODUCTS

ID: 1445

GRP fan blades from cooling tower

Fertilizer Producer, Indonesia

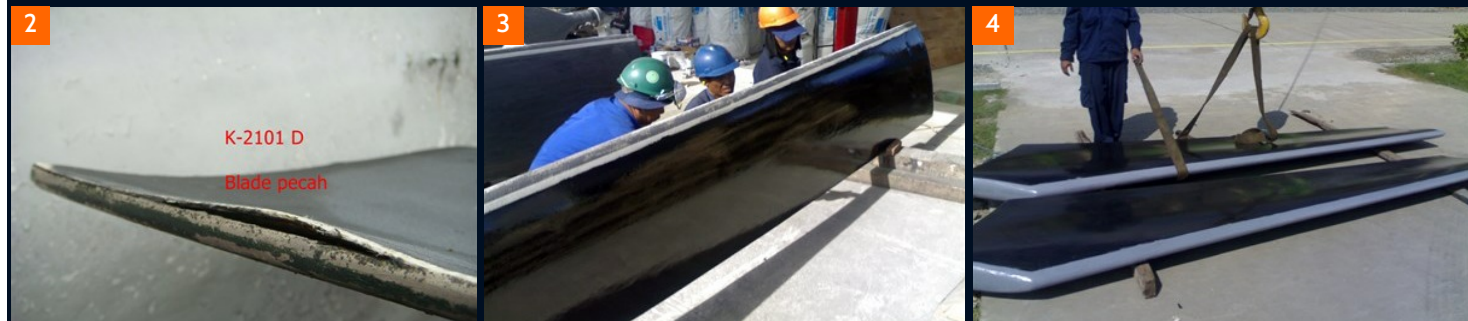
Erosion on leading edges, cracks and flaking on trailing edges of cooling tower fan blades caused by UV degradation, erosion and impingement. This reduces the overall efficiency and operation of the cooling system.

1. Damage on leading edges
2. Flaking on trailing edges
3. Belzona application
4. Completed blades after coating with Belzona 1321 and Belzona 5811

The application was carried out in accordance with Belzona Know-How System Leaflet FBC-1. The Leading edges and trailing edges were rebuilt with Belzona® 1311 and subsequently coated with Belzona® 1321. Blade body was coated using Belzona® 5811.
