# BELZONA REPAIRS OIL LEAK ON TRANSFORMER FIN

ID: 1483

Oil cooled electrical transformer

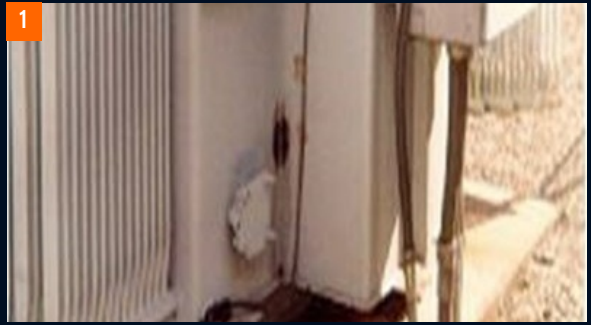
1. General view of the transformer
2. Close up of oil leak area
3. Completed application. Leak sealed with Belzona 1161

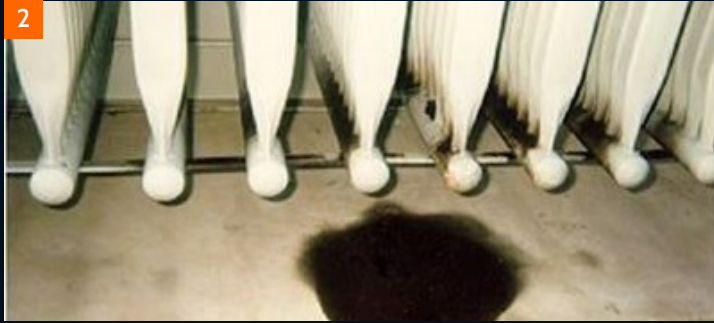
Oil leaking from fins
