# BELZONA REPAIRS LEAKING FLANGE CONNECTION ON TRANSFORMER

ID: 1484

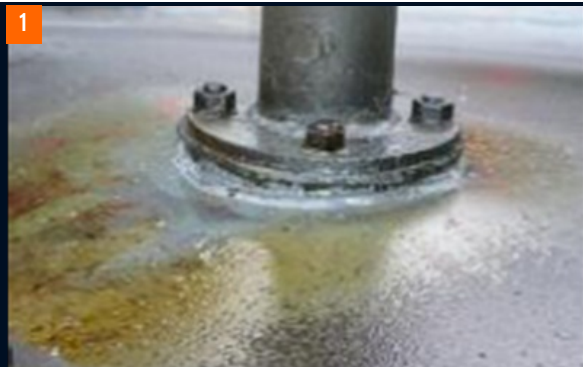
Oil leaking from flanged pipe connections

1. Oil leaking from flange
2. Belzona 1161 being applied
3. Inspection of Belzona 1161 application

Repairs were carried out in-situ without the need to take the transformer off-line. Belzona® 1161 was applied without having to drain the transformer oil. Repair was total success.
