# BELZONA REPAIRS TRANSFORMER FLANGE OIL LEAK

ID: 1491

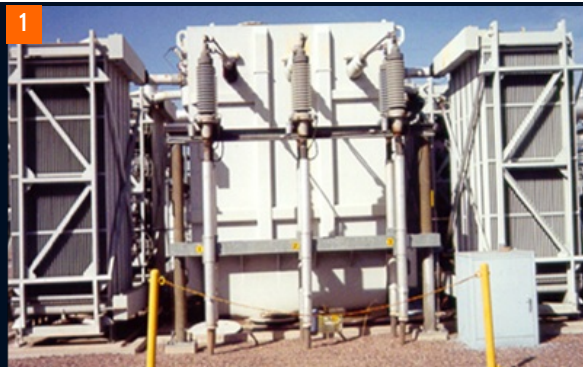
Oil leaks raised maintenance, EPA and safety concerns. Replacement of gaskets would require shut-down and dismantling of equipment.

1. Oil leak area of transformer
2. Seal with Belzona 1221, then pour Belzona 2221 encapsulated the flange
3. Application completed

The application was carried out in accordance with a modified of Belzona Know-How System Leaflet VPF-11 and GSS-4. Leaks were firstly stopped by using Belzona 1221. Mould was constructed and a fluid grade of Belzona 2221 was poured in to encapsulate the flange.
