# BELZONA REPAIRS LEAKING TRANSFORMER FINS

ID: 1492

Fins on oil filled transformer

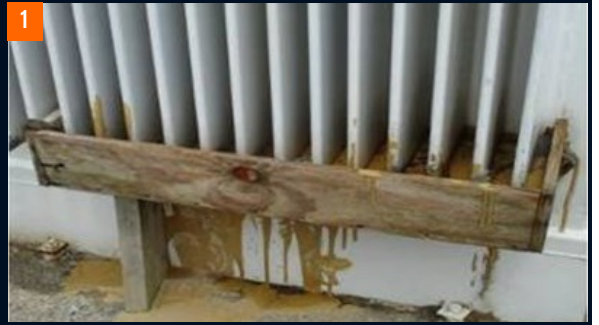
Lower edge of fins corroded and starting to leak. Problem caused by sheep rubbing against fins, damaging paint system.

1. Previous temporary repair
2. Surface preparation
3. Bonding with Belzona 1161
4. Completed application
