# BELZONA 2211 SEALS OIL LEAKS ON SWITCH RELAYS

ID: 151

Earth bushings on an oil filled switching unit

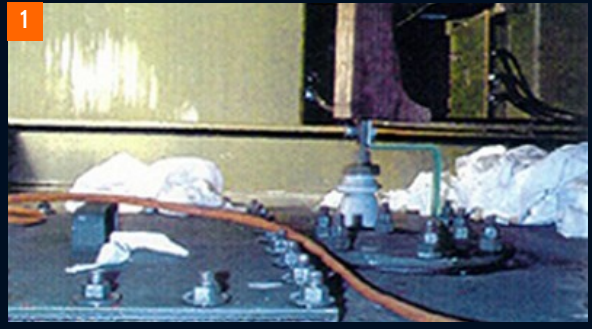
Up to five litres of oil per day were leaking through the bushings. Full repairs, working inside the reactor were deemed to contravene their Duty of Care, so alternatives were sought.

1. One of the leaking earth bushings
2. Work underway on the bushing (Note wedge in place to stem leak.)
3. Application of Belzona 2211 complete
