# GAS LINE REPAIRED WITH BELZONA SUPERWRAP SYSTEM

ID: 1579

18" Gas Line transporting natural gas

Oil Refinery, Argentina

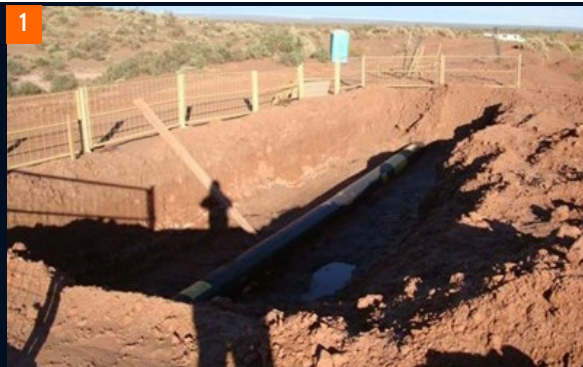
Gas line was suffering from wall thickness loss due to internal corrosion. A thin wall defect of dimensions 2.1x2.4x0.25" was detected on a section of the pipework.

1. Gas Line exposed
2. Surface Preparation by Sponge Jet
3. Applying product around the pipework section
4. Application completed
