# BELZONA PROVIDES COST EFFECTIVE SOLUTION TO CONVEYOR BELT REPAIRS

ID: 1621

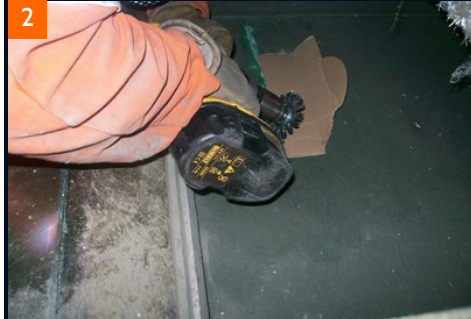
An L shaped cut approximately 300mm across the length of the belt was found in a new conveyor belt.

1. Damaged conveyor belt - L shaped cut
2. Surface being prepared using a wire brush on a hand drill
3. Belzona Conditioner applied with 1 coat of product and and reinforcing tape laid on top
4. Completed conveyor repair

The application was carried out in accordance with Belzona Know-How system Leaflet SHM-1. Top cover was cut back before repairing with Belzona® 2311 incorporating Belzona® 9341 (Reinforcement Tape).
