# BELZONA SEALS OIL LEAK FROM TRANSFORMER CABLE GLAND

ID: 1642

33kV/11kV Transformer Cable Gland

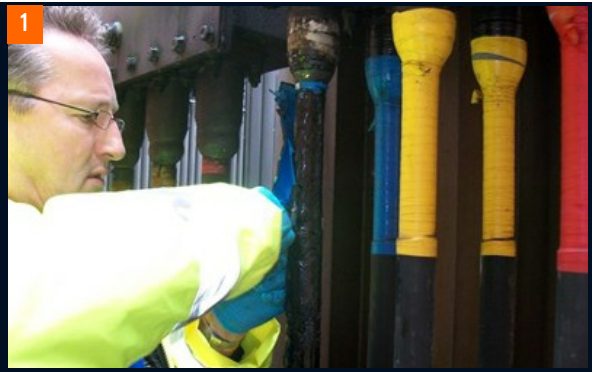
Due to movement and vibration from the transformer, the lead seal to the cable gland on the blue phase of the 11kV distribution cable had cracked. The cables are oil cooled and oil was leaking through the gland. This had been leaking for many years but due to increased pressure from the Environment Agency on electricity distribution companies to reduce the amount of oil leaked to ground, the Company approached Belzona for assistance.

1. Leaking cable gland, previous attempts to stop leak had failed.
2. Substrate cleaned and prepared making the cracked gland clearly visible.
3. Leak stopped using Belzona 1291 and Tourniquet
4. Gland wrapped using Belzona 1161.
