# BELZONA SUPERWRAP PIPE REPAIR

ID: 1982

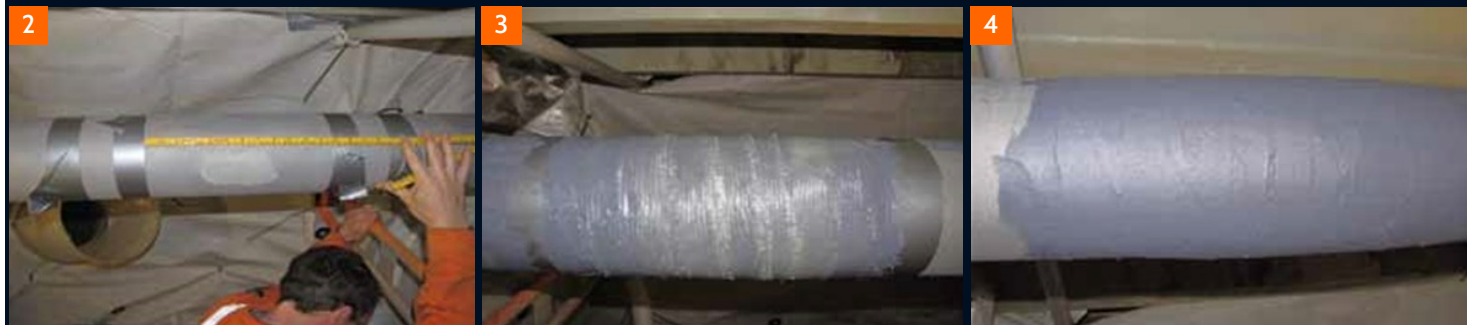
There were two 10mm holes through wall defects in the pipe caused by local bacterial corrosion. Prior to the application, the defects were sealed with a patch of Belzona® 1211 to provide a temporary leak sealing repair. The client needed the pipe system back in service as soon as possible.

1. Defective pipe prior to repair
2. Grit blasting and preparing the application area
3. Second spiral applied
4. Finished application

A Belzona® SuperWrap repair, compliant to ISO/TS 24817 and ASME PCC-2 Article 4.1, was applied to provide reinforced protection to the weak and vulnerable areas of the corroded pipework. Using a Belzona® SuperWrap repair, the client was able to eliminate the need for hot work and this approach also minimized the time the pipe system was out of service. The pipe repair was completed within two hours and was back to full strength following a forty-eight-hour cure period.
