# BELZONA REPAIRS TO STEEL ROLLING MILL

ID: 204

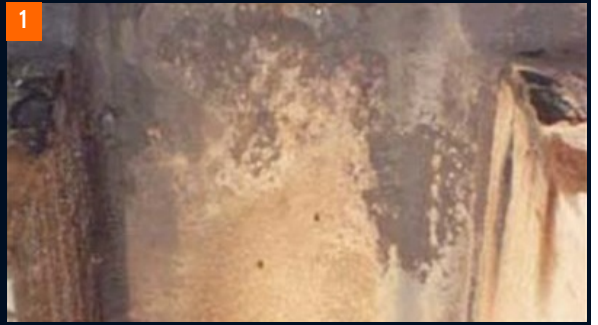
Corrosion caused by cooling water between mill housing and load block. Increased clearance leads to loss of pre-tension on holding bolts.

1. Corrosion evident after grit blasting
2. Molds being positioned
3. Surfaces reformed with Belzona
