# STEEL PLANT NOW BACK ON LINE WITH BELZONA WRAP

ID: 2197

Leaking 24 inch cast iron coke oven gas main from the coke ovens to the power plant .

Steel Plant, Teesside, UK

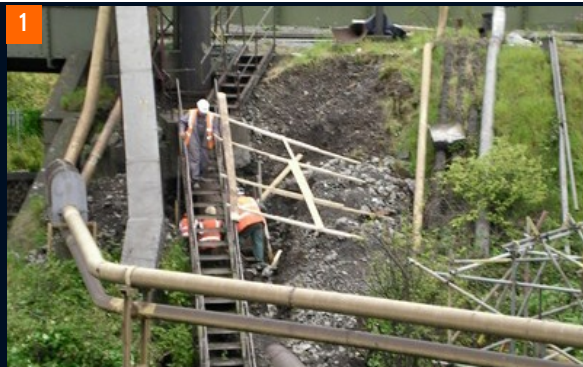
1. Site access to excavated pipe section
2. Excavated 24 inch Gas Main with crack identified
3. Completed Belzona 1121 wrap

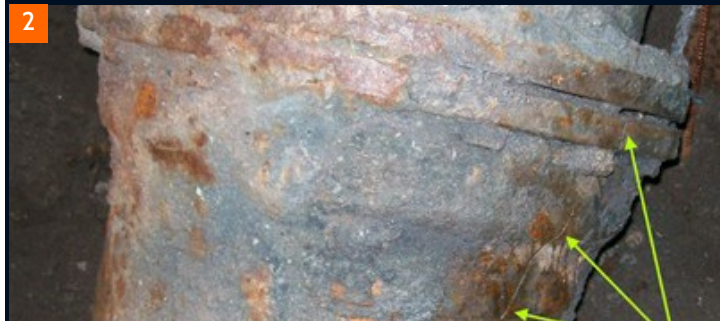
The gas leak on the cast iron pipe was detected and once excavated a 10 inch long crack over the socket area was found to be the cause. The pipe was critical to the plant operation so an immediate solution was required. The coke oven gas had a typical internal pressure of 500 mbar and client needed to reduce the repair period to a minimum.

The crack was terminated and vee'd cut in accordance with Belzona Know-How System Leaflet VPF-8. Belzona® 1121 was used to pack the gasket and create fillets on either side of the flange, before conducting a wrap repair in accordance with Belzona Know-How System Leaflet VPF-11a.
