# STEEL PLANT BACK ON LINE WITH BELZONA WRAP

ID: 2238

Leaking cast iron coke oven gas pipe.

Steel Plant, Teesside, UK

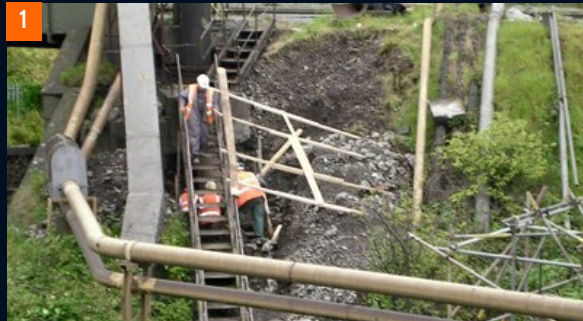
1. Site access to excavated pipe section
2. Excavated 24 inch Gas Main with crack identified
3. Completed Belzona 1121 wrap

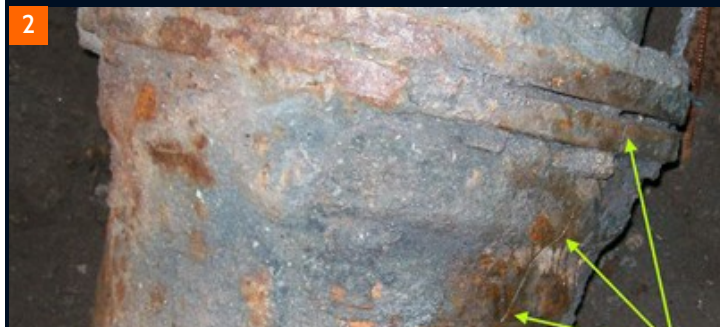
Gas leak on the 24 inch cast iron pipe was detected and once excavated a crack of 25cm length over the socket area was found to be the cause. The pipe was the gas main between the coke ovens and the power plant and so an immediate solution was required. The coke oven gas had a typical Internal pressure of 500mBar and client needed to reduce the repair period to a minimum.

The crack was terminated and V cut in accordance with Belzona Know-How System Leaflet VPF-08. Belzona 1121 was used to pack the gasket and create fillets on either side of the flange, before conducting a wrap repair in accordance with Belzona Know-How System Leaflet VPF-11a.
