# BELZONA STORAGE TANK PATCH REPAIR

ID: 2404

Defective vertical seam of a fuel oil storage tank.

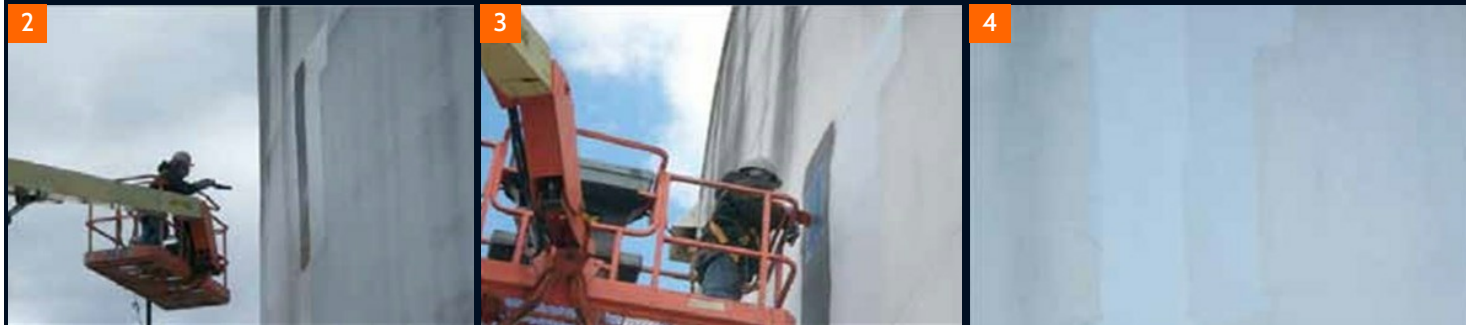
A vertical weld was found to be porous and product was weeping from a tiny porous spot less than 2mm in diameter. There was no corrosion or thin walling. The defect was located at the 30' level of a 56' high tank. The client needed the tank to be back in service as soon as possible.

1. Defect prior to repair
2. Repair area prepared by abrasive blasting
3. Application of Belzona SuperWrap patch
4. Belzona SuperWrap patch inspected and painted

The defect was sealed using a Belzona® SuperWrap patch and the repair was continued vertically along the entire length of the weld as a precaution. Belzona's compliant, engineered repair enabled the client to eliminate the need for hot work on the tank, which was a safety concern. This approach also minimized the time the tank was out of service. The tank was repaired, inspected, and ready for service within three days. Furthermore, the tank was back to full height of product three weeks later with successful results. The Belzona repair is compliant to ISO/TS 24817, DOT Title 49, Chapter 1, Part 192, and ASME PCC-2 Article 4.1 standards and as such provides a permanent, reinforced, composite repair to the tank.
