# BELZONA SEALS SKYLIGHTS OVER PRODUCTION HALL

ID: 2456

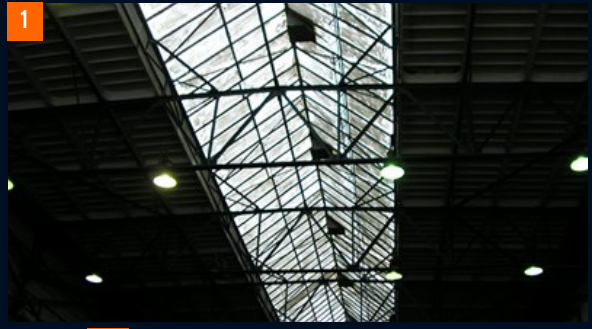
1. Skylights on the production hall
2. Corrosion of steel frame
3. Application in progress
4. The skylights in "as new" condition

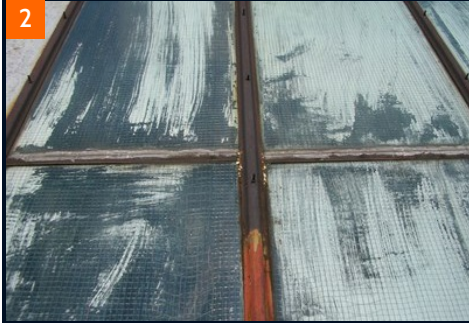
Corrosion of steel frame and rubber seal degradation on the skylights, caused by the effects of weather, was allowing rainwater to leak directly into the production hall creating safety issues and damage of interior machinery.

Application was carried out in accordance with Belzona Know-How System Leaflet RPA-3. A fully reinforced Belzona® 3111 system was applied to bridge over the glazing bars and seal onto the glass.
