# MINE LOCOMOTIVE AXLE REPAIR

ID: 2457

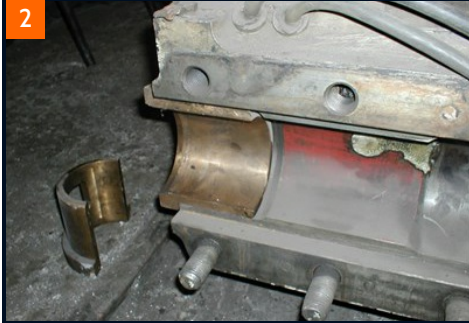
Due the slide assembly wear of shaft axle in bronze bearing the shaft unloading appeared. Direct mark of this failure is big noise level.

1. Mine locomotive
2. Failure bearing
3. Repair in progress
4. Renovated axle
