# BELZONA REPAIR ON 10,000 HP SULZER MARINE DIESEL ENGINE

ID: 249

## PROBLEM

Pitting corrosion on engine block caused o-ring seals to leak.

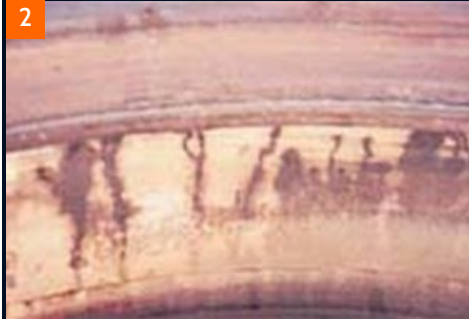
Each cylinder is 36" in diameter, each had three corroded lands about 4" wide. Customer felt conventional weld repairs would have been too risky, and that Belzona was the only viable alternative.

1. View of Sulzer Engine
2. Close-up of pitted, corroded area on engine block
3. Prepared area after machining, before Belzona
4. View of machined Belzona
