# BELZONA PUMP REPAIR PROVIDES OVER TEN YEARS OF UNINTERRUPTED SERVICE

ID: 26

Primary fan pump

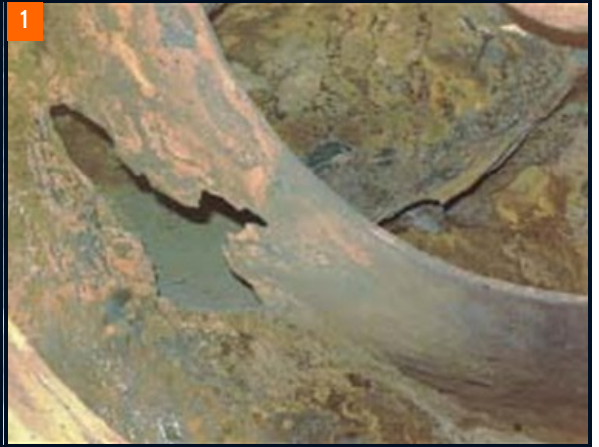
Pump suffered from erosion/corrosion and was completely destroyed after four years of operation

1. Severe damage
2. The wear ring seats rebuilt, clamps help ensure proper alignment
3. Belzona 1321 (Ceramic S Metal) coating
