# BELZONA KEEPS THIS SPLINE ON THE STRAIGHT AND NARROW

ID: 284

Planetary gear spline for mandril mill manufacturing pipe.

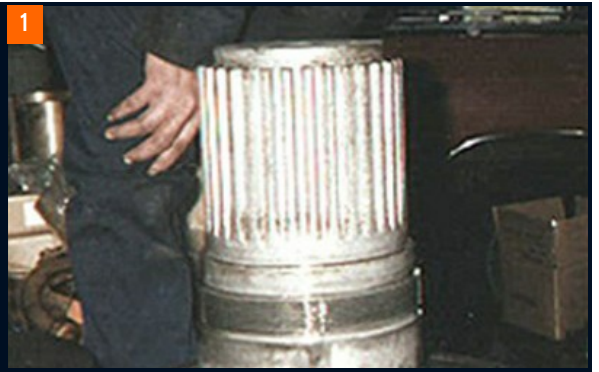
Wear of the shaft spline due to abrasive contamination as well as misalignment caused excess slop in the drive and eventual failure of the mandril unit.

1. The equipment prior to the application
2. Belzona 1111 is being applied to the spline
3. The spline and socket are being mated
4. Excess material is being removed

The application was carried out in accordance with Belzona Know-How System Leaflet MPT-5. Belzona® 9411 (Release Agent) was applied to the socket and Belzona® 1111 (Super Metal) was applied to both the socket and spline before mating the two pieces.
