# BELZONA REPAIRS CROSS THREADED FITTINGS WITHOUT MACHINING

ID: 300

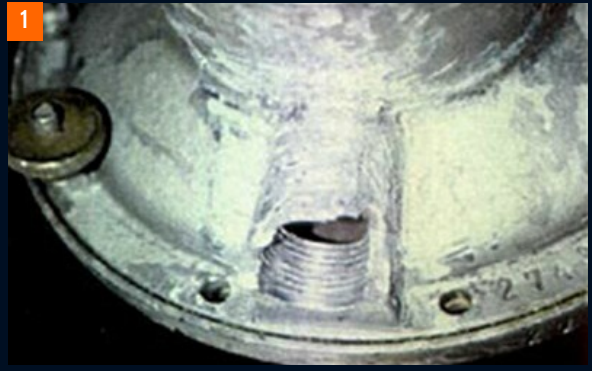
Operator error in cross threading the inlet fittings in the casing of two steel venturi eductor nozzles damaged the units and were unable to function properly.

1. View of damaged venturi casing
2. View of eductor nozzles during forming process
3. Completely reformed threads

Belzona® 9411 (Release Agent) was applied to the male threaded fitting and allowed to dry for at least 20 minutes. Belzona® 1111 (Super Metal) was then applied to the threads of both the male and female components and brought together immediately. Following full cure, the fittings were removed to reveal perfectly reformed threads without machining.
